# Town of Claresholm

# Infrastructure Master Plan

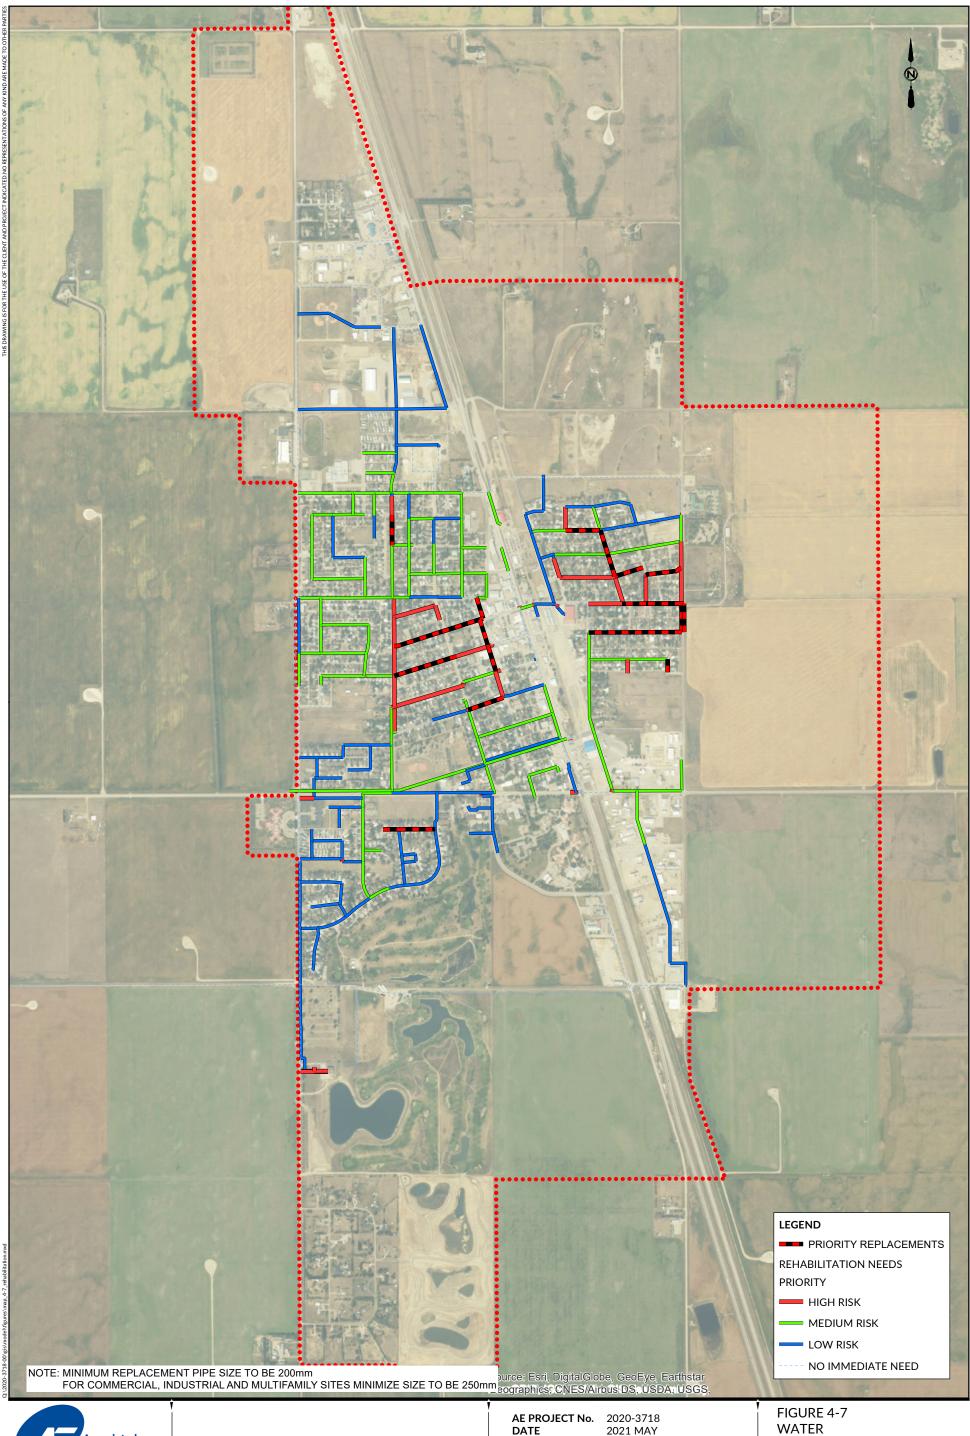
WATER REHABILITATION PLAN

In order to maintain a distribution system in good operating condition, water mains must be replaced as they near their end of life. The Town has had a proactive replacement program that has replaced most of the cast iron water main in the system. Due to corrosion processes, cast iron water mains are typically found to be in poor condition in most water distribution systems.

Wherever possible, water mains that do not meet minimum pipe sizes should be the first mains included in the rehabilitation program. As the remainder of pipes in the system age, it is likely that other pipe materials in the system will be subject to failure as they reach their end of life.

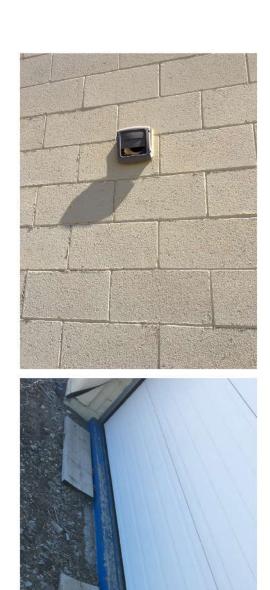
ADDRESS			OCCUPIED
	4505 – 5TH STREET E	EAST	IN USE
<b>OVERALL STATE:</b>	AGE	<b>BUILDING DESCRIPTION</b>	
FAIR	UNKNOWN	EAST SIDE RESERVO	DIR
<b>OVERALL ISSUES:</b>			
TREATED WATER LEAKING TO SU	MP & PUMPED TO DRAF	INAGE	
TANK WALL TO ROOF SEALANT FA	AILING

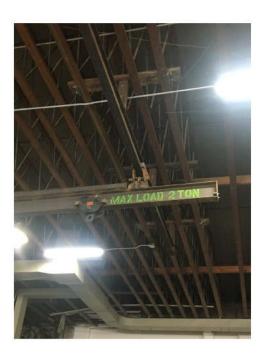
ADDRESS			OCCUPIED						
	YES								
OVERALL STATE:	AGE	<b>BUILDING DESCRIPTION</b>							
GOOD	GOOD 2010 WATER TREATMENT PLA								
OVERALL ISSUES:									
WATER PENETRATION THROUGH CONCRETE FLOOR SLAB									
GENERALLY GOOD CONDITION
