REPORT

Phase I Environmental Site Assessment Area Structure Plan

Alberta Road, West of Highway 2 and East of 8th St

AUGUST 2023

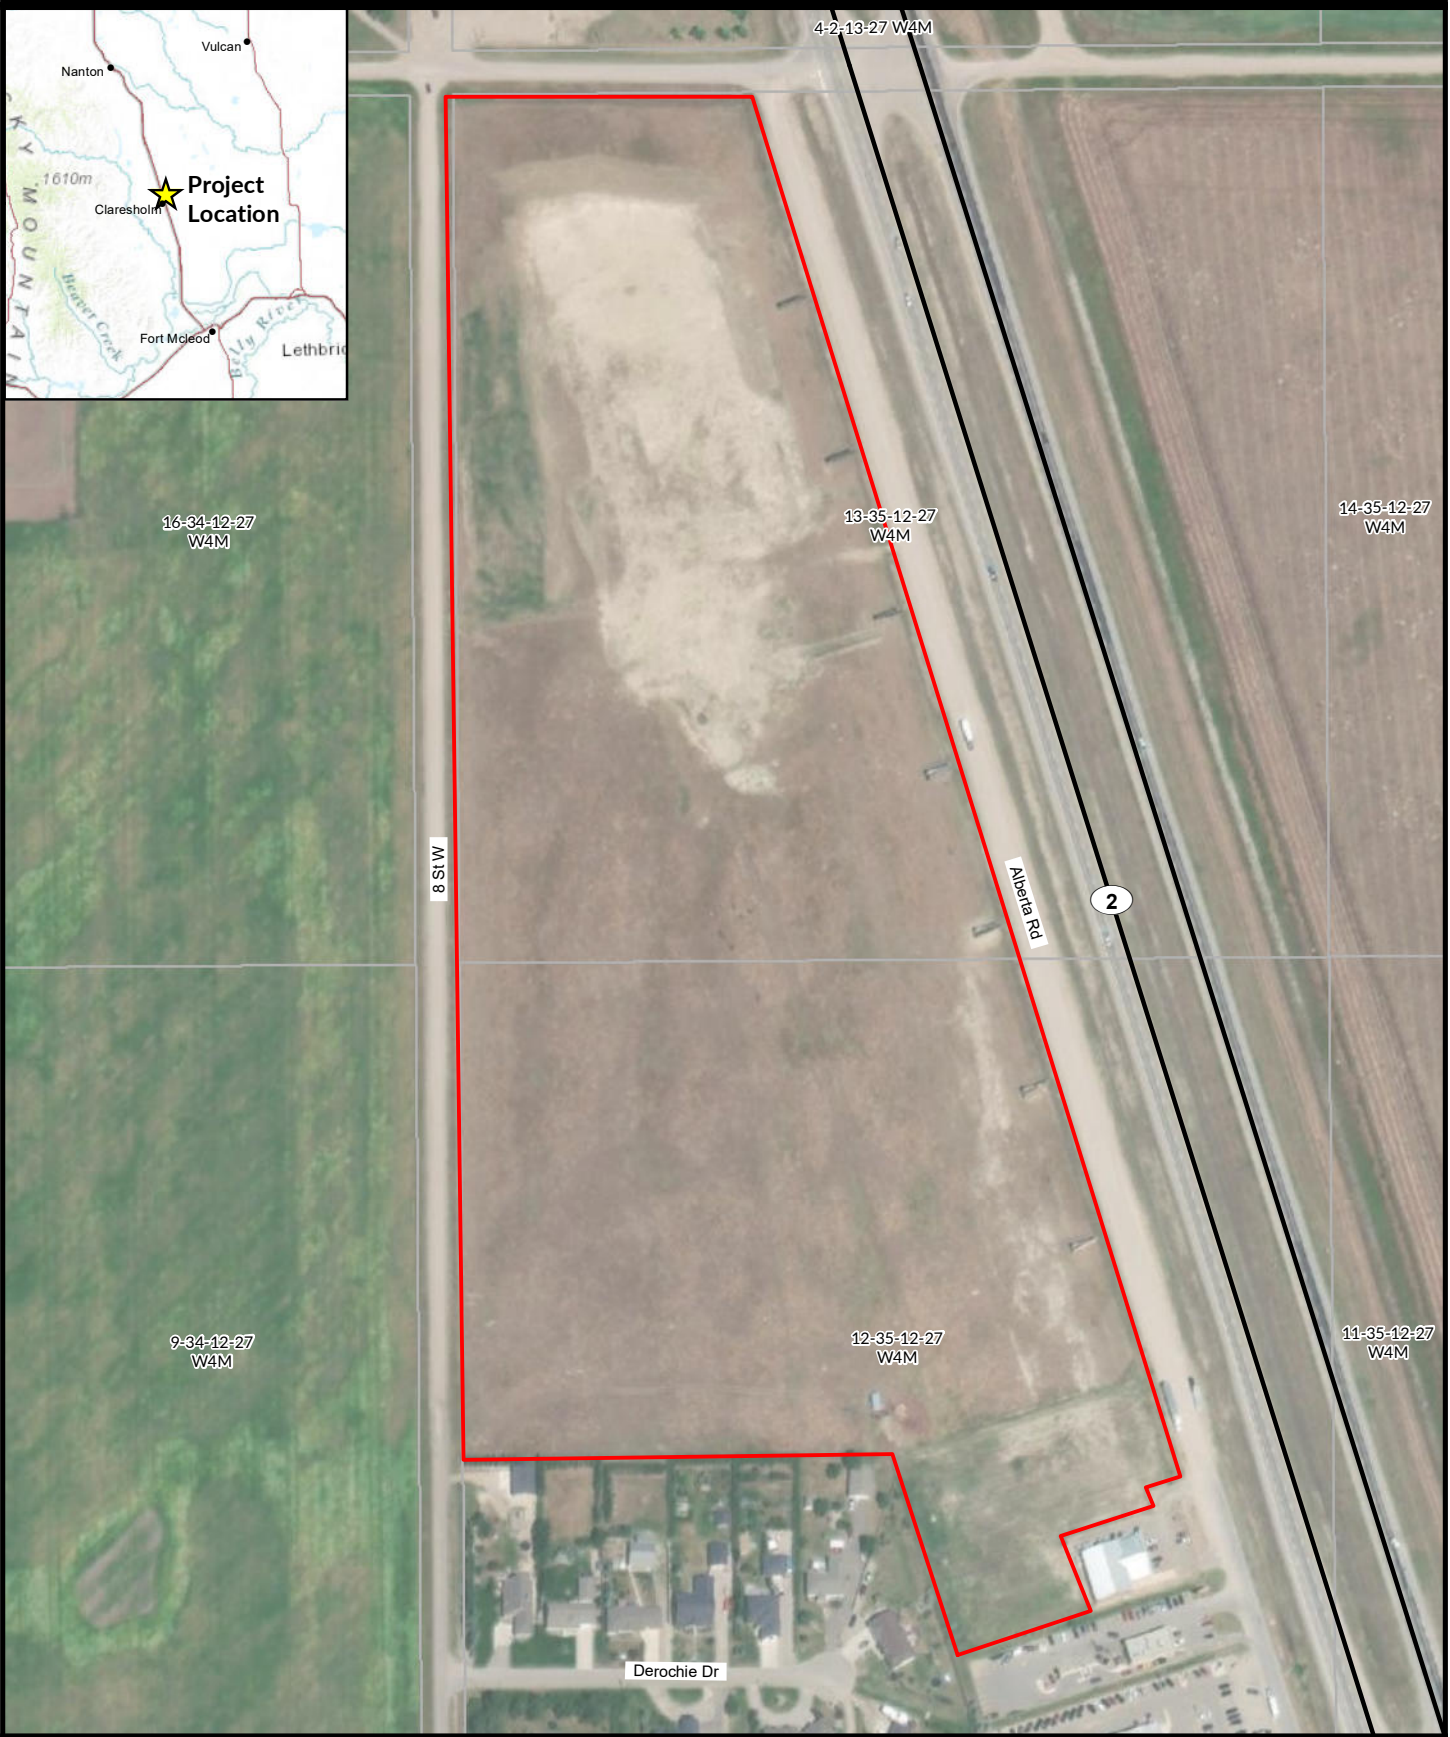
**FIGURE 1-1
PROJECT LOCATION**

The Site is approximately 38 acres, including a Portion of Block 7, Plan 7410624; Linc 0032892564 and Lot 5, Block 8, Plan 0715848 (GoA 2023). These lands are situated west of Highway 2 and Alberta Road, and east of 8 Street W in Claresholm, AB. The Site boundaries are shown on **Figure 1-1, Appendix A**.

The regional topography slopes gently south-southeast. Locally, the Site is relatively flat and gently slopes to the south (Figure 1-1, Appendix A).

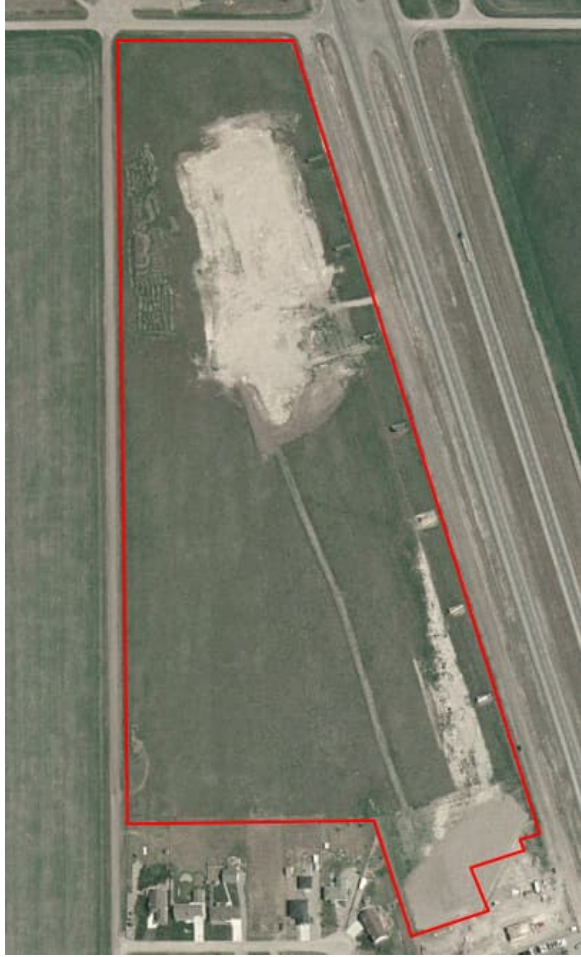
Apologies for the back and forth but I must correct my earlier question related to the "salt mound" in the northern part of your property. It seems as though your property may have been cleared sometime between 1999 and 2005 (see photo below) with some sort of fill material brought in (which you mentioned previously).

Present day – our site visit indicated that there was a "white material" in the same area - please could you confirm that this is in fact salt, or let me know what it could otherwise be at your property.

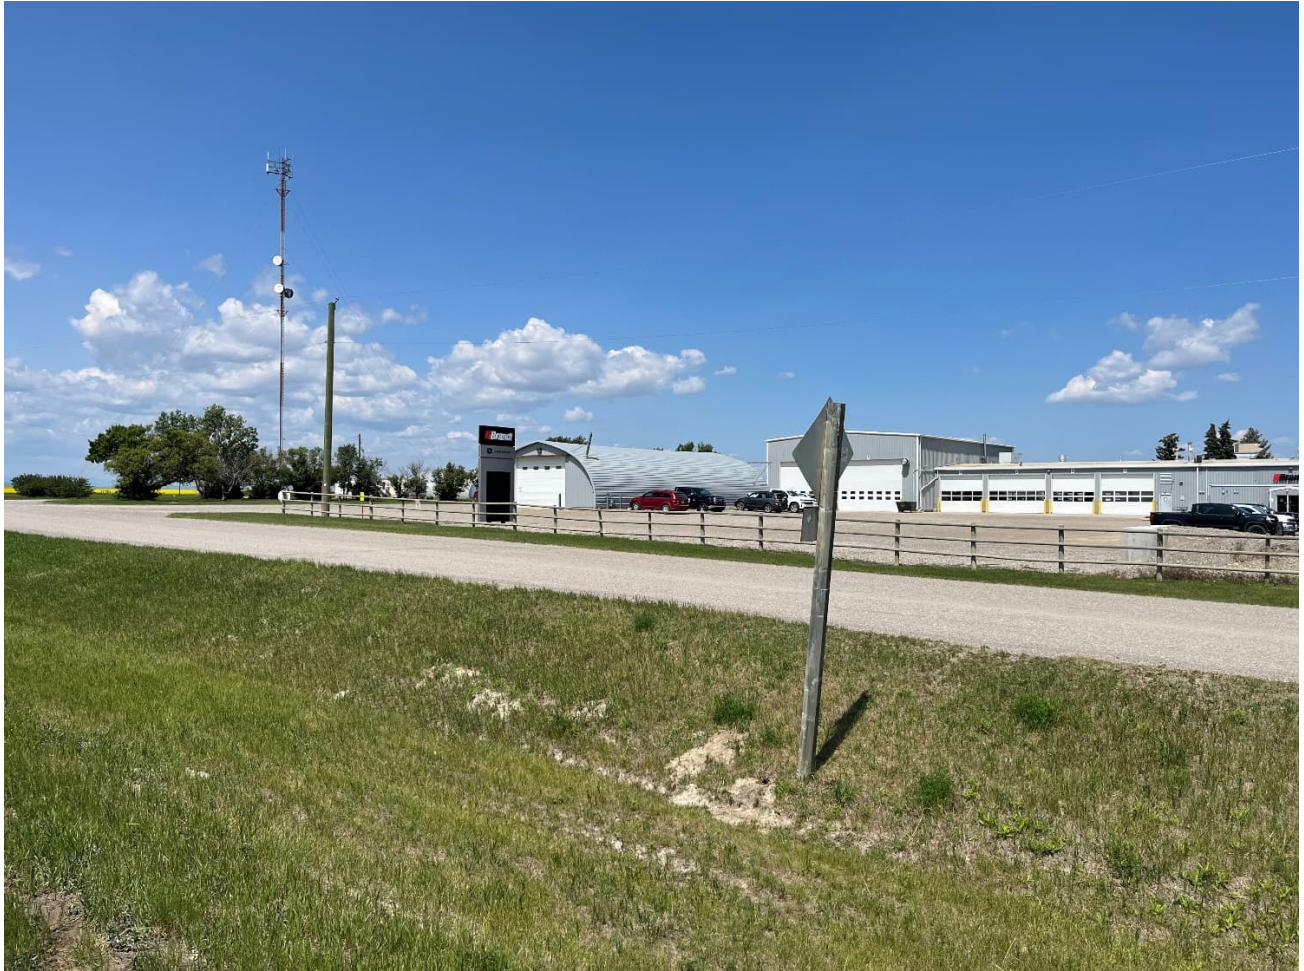
The property to the north belongs to an agricultural machinery dealership (Brandt Agriculture), and is approximately 30 m away from the boundary of the Site. The building on the property is a vehicle and equipment repair workshop composed of steel, concrete, and metal sheets. The heating fuel source is natural gas and cooling is by air conditioning. Mechanical equipment on the property includes hydraulic lifts, vehicle hoists, and farming machinery. Fuels and other hazardous materials are possibly stored on Site. The interior of the building was not inspected. This property represents an Area of Environmental Risk to the Site (**APEC 1**).

Photo 1 View of the northern boundary of the Site, and adjacent farm machinery dealership (facing north)

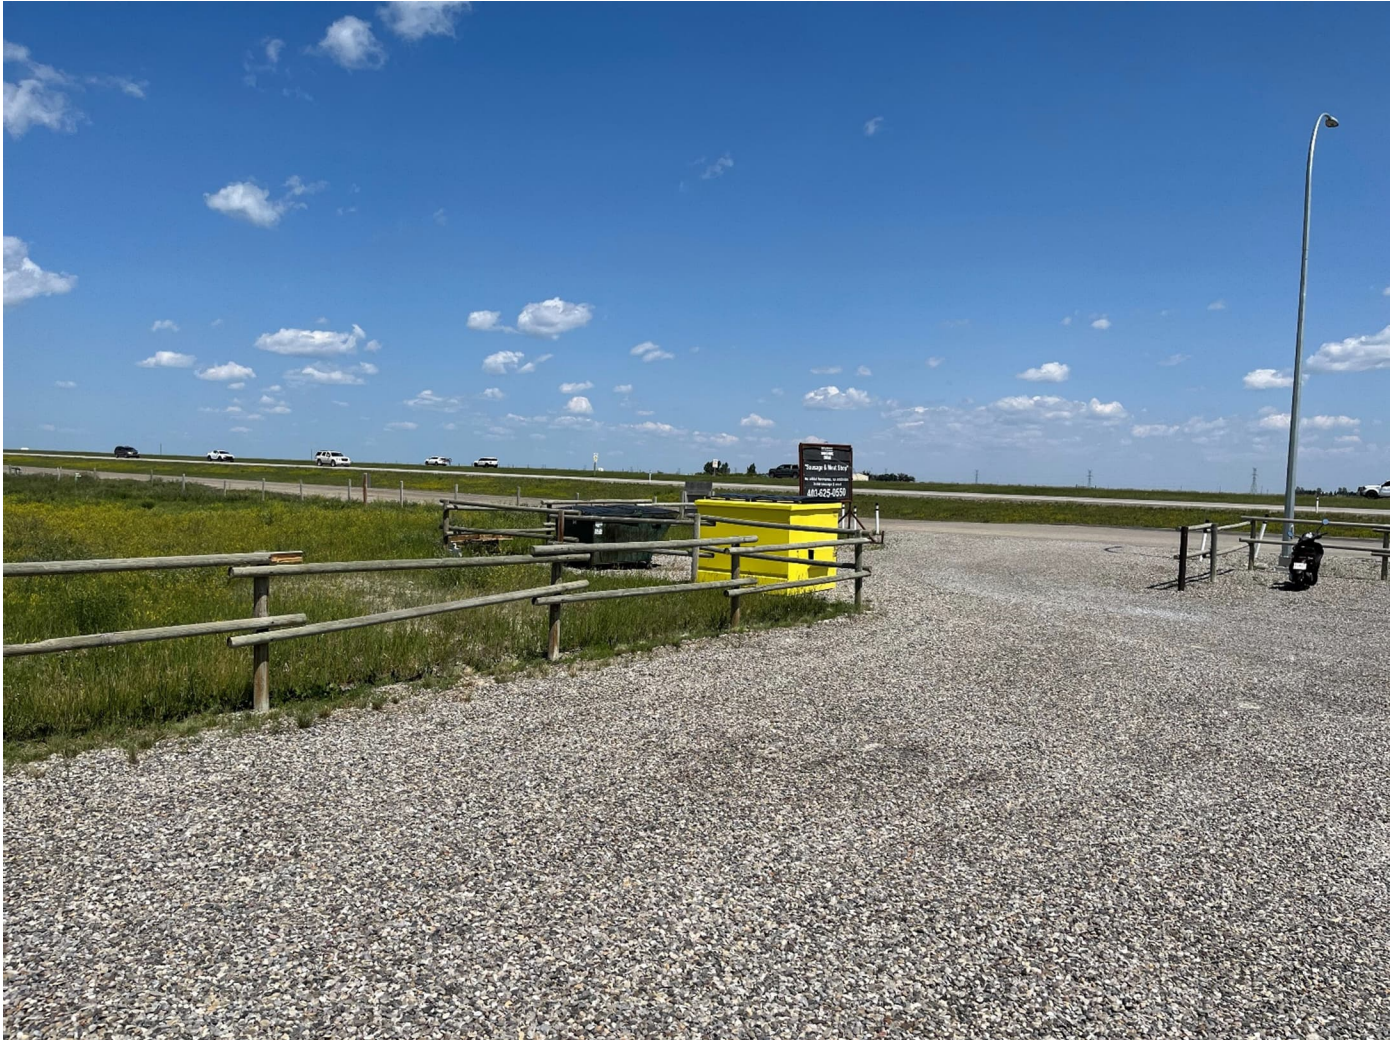
The properties on the southern boundary are used for residential and commercial purposes. Meadow Creek Sausage and Meat is situated approximately 5m south of the Site. It is a one-story building comprised of a steel frame, concrete flooring and metal sheet roofing. The building uses natural gas for heating and air conditioning for cooling. Onsite staff confirmed that the business uses the municipal sewage system and potable water supply. A drain entering a drainage channel was observed from the back of the building. The second commercial building on the southern boundary is a Tim Hortons, situated approximately 13 m south of the Site. The building is mostly concrete, with some tile flooring. Heating and cooling are by natural gas and air conditioning, and fibreglass was used for insulation. This building also uses the municipal sewage system and potable water supply. The third commercial building is a preowned vehicle dealership (Davis Chevrolet Buick GMC). It is situated approximately 40 m, south of the Site and is composed of a steel frame, concrete flooring, and metal roofing. The building uses natural gas for heating and air conditioning for cooling. Mechanical equipment on Site includes hydraulic lifts and vehicle hoists. Visible stains were observed on the property. Above ground storage area was also observed as well as a hazardous waste collection in the back. This property represents an Area of Environmental Risk to the Site (APEC 2)

Photo 2 View of the south boundary of the Site, and waste storage on adjacent commercial property (facing northeast)

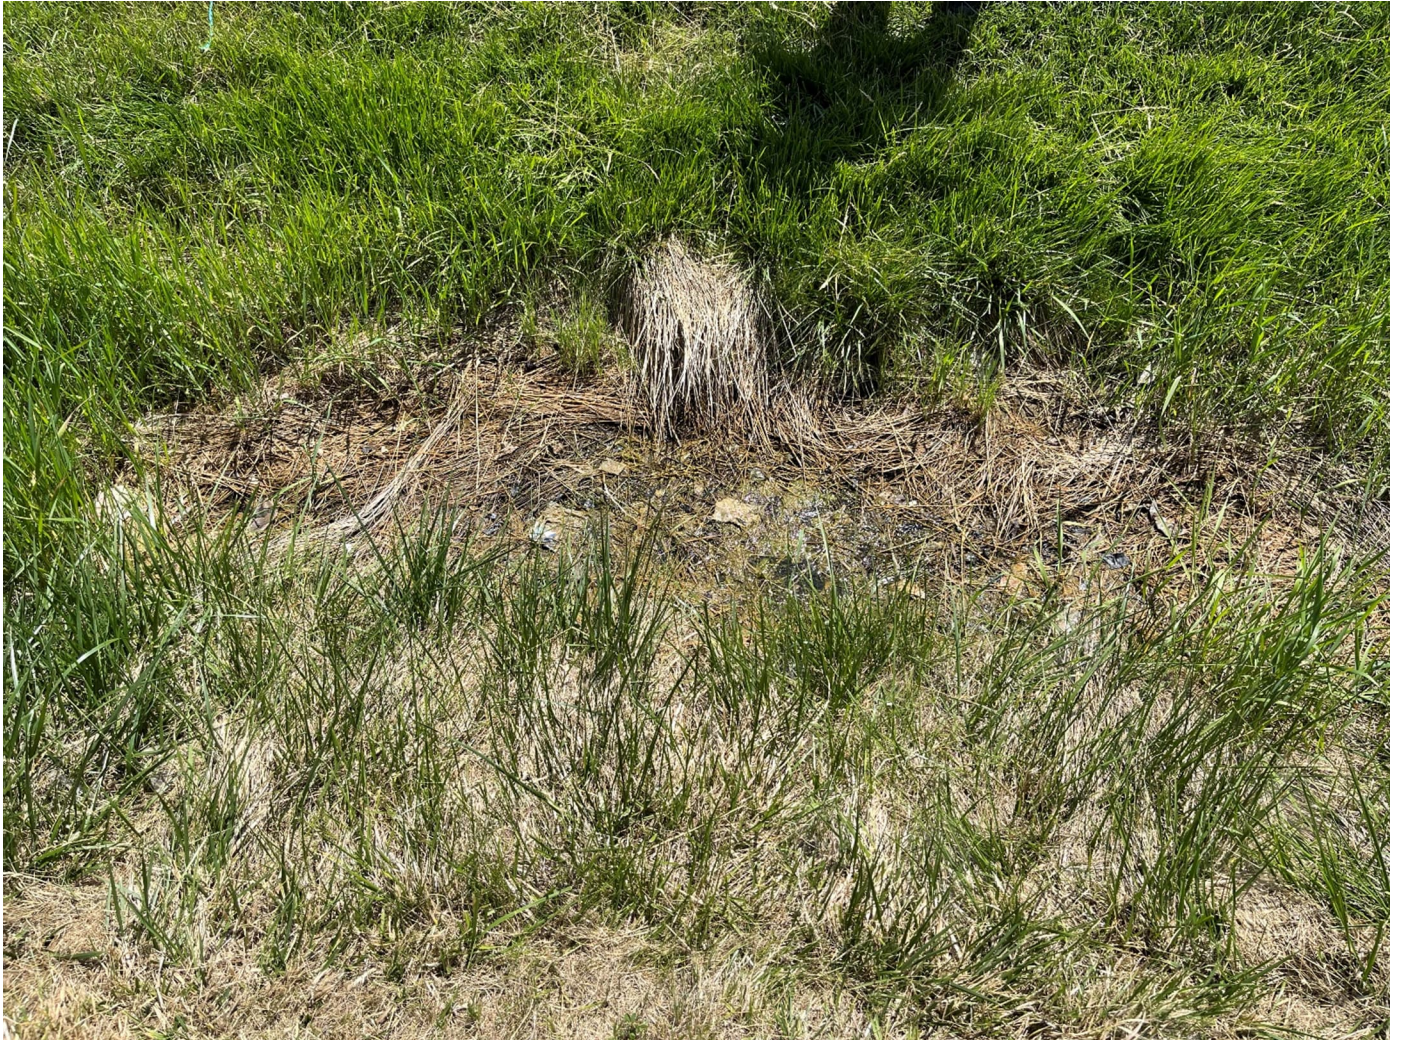
The area of distressed vegetation in the south of the Site in the former Parking/Storage Area just north of (Meadow Creek Sausage and Meat Ltd., is relatively small with no readily apparent cause. The grass within a small area (1.5 M²) was yellow and the ground surface appeared saturated. The adjacent grasses were green and thriving. Based on the size of the APEC it is believed to represent a low environmental risk and does not warrant further investigation prior to beginning construction. The contractor should be advised of the small area of stressed vegetation at the Site, and soil sampling of the APEC may be completed in conjunction with construction activities, if deemed necessary. Associated does recommend caution while excavating in the area, and examining for signs of contamination in the subsurface soils.

Photo 3 View of distressed vegetation and staining on the south section of the Site (facing north)

Based on the information gathered during this Phase I ESA, there are no onsite APECs that warrant further, standalone investigation. The area of stressed vegetation in the south section of the Site is expected to present a low environmental risk to the Site, based on its limited size and lack of apparent cause, and is thought to be associated with the former parking/storage area. The area of stressed vegetation in the north is thought to be associated with natural levels of salinity/sodicity parameters uncovered during a borrow pit excavation, and does not represent an APEC for the Site, however there may be benefit in sampling the area to evaluate the levels of sodicity/salinity in the soil which may have an effect on the suitability of the soils for reuse at the Site. Soil sampling of these impact areas could be completed in conjunction with construction activities at the Site.

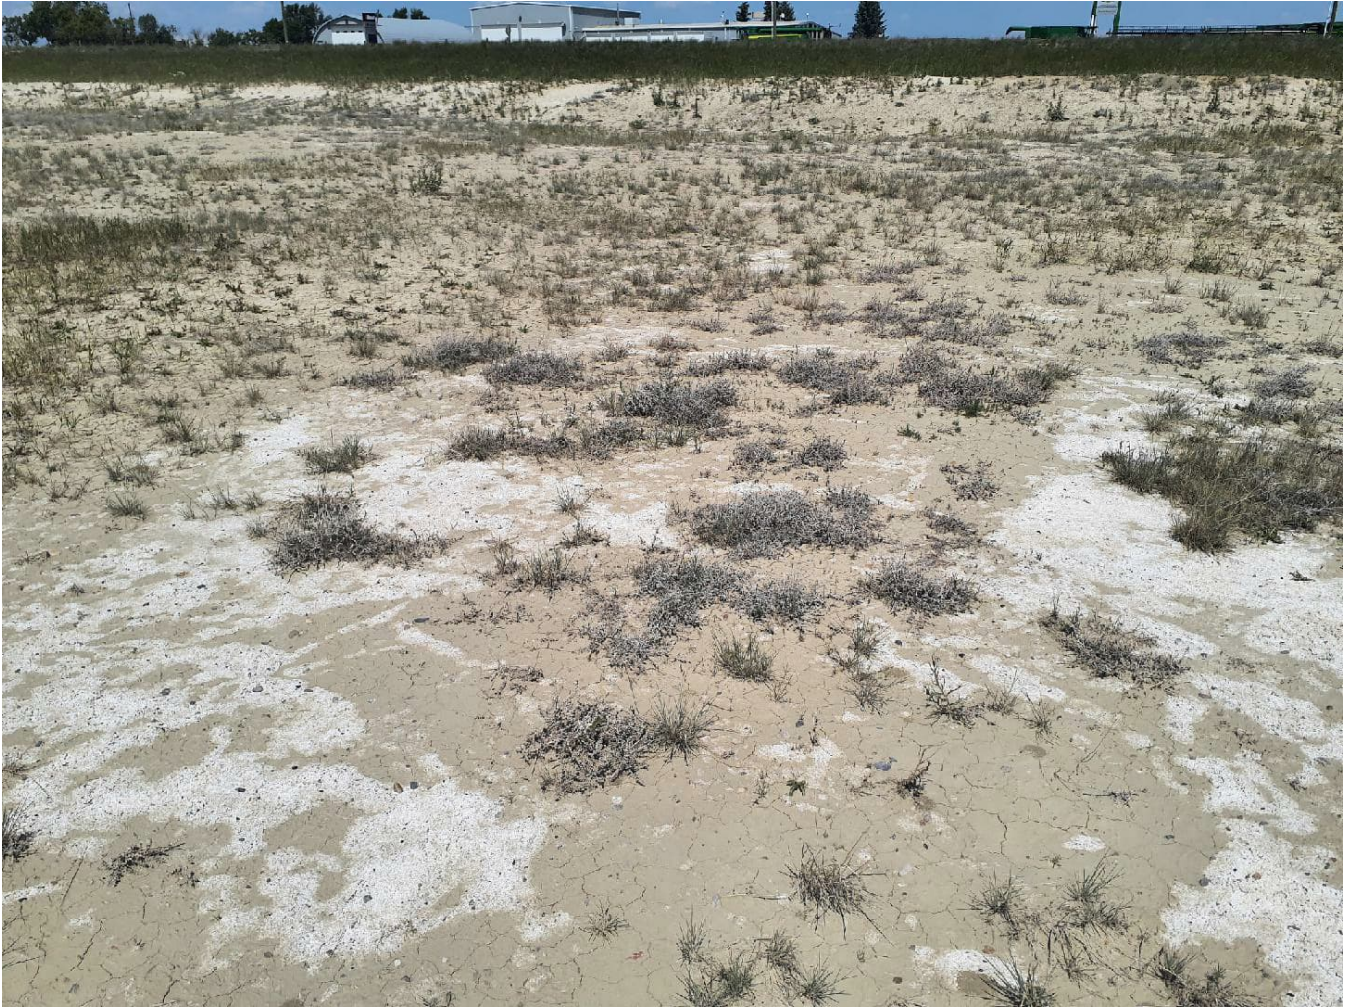
The area of stressed vegetation in the north of the Site is lower in elevation than the surrounding land, and is bordered by earth berms. The appearance is consistent with a borrow pit excavation, and could potentially be the source of clay removed from Site, as discussed in **Section 5**. A white coloured layer covering the soil was observed on the property in the north, which is assumed to be causing stressed vegetation. The white coloured layer observed on Site appears consistent with the description of sodic and/or saline soils (McKenzie and Woods 2010), and may be the contact salinity layer referenced in **Section 3.5**. Sodic soils have high levels of sodium in the layer of soil beneath the topsoil which can result in reduced plant growth, plant toxicity, and changes to the soil structure that reduce water infiltration. (McKenzie and Woods 2010) The owner stated this area sometimes pools rain runoff which has leached up small amounts of native salinity (Wilson, pers. Comm., 2023), but no assessment has taken place to assess the salinity or sodicity levels at the Site. Based on the information provided from the site visit, the information provided in Section 3.5, and Section 5, it is believed that the stressed vegetation in the north is the result of naturally occurring background salinity/sodicity that was uncovered during the borrow pit excavation. The stressed vegetation does not represent an APEC for the site, however the soil changes referenced above reduce water retention in sodic soils and may have an effect on the ability to achieve proper compaction, impacting their reuse on Site. Soil sampling of the stressed vegetation area for salinity parameters may be performed in conjunction with pre-construction activities (i.e. Geotechnical investigation) to assess the soils.

Photo 4 View of the distressed vegetation and white crust in the northern section of the Site (facing east)

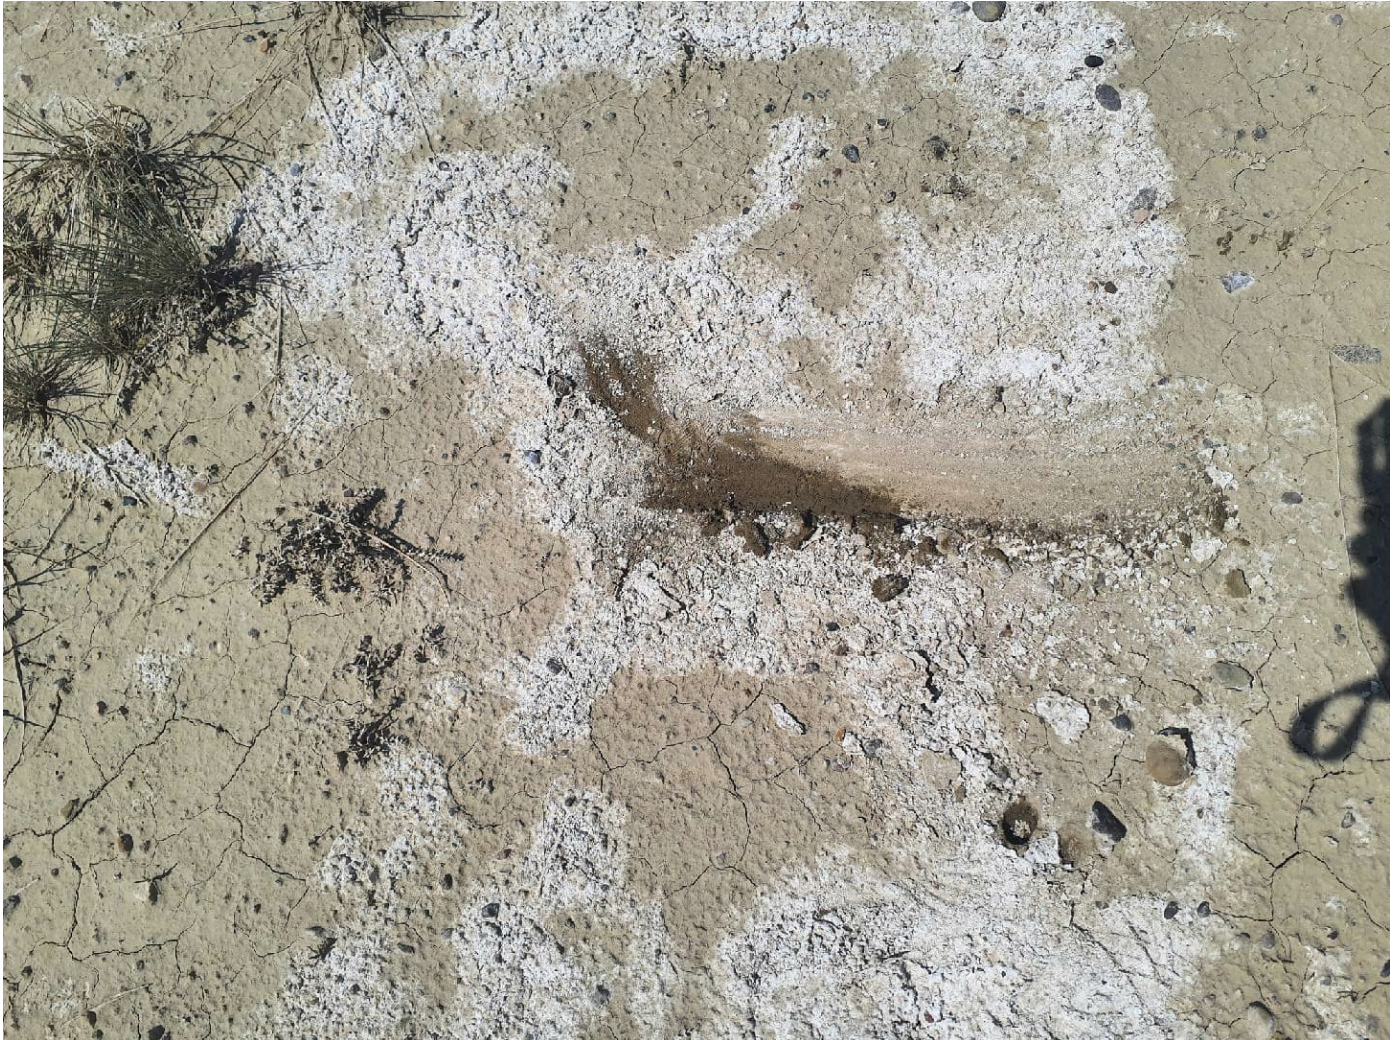
Photo 5 View of the distressed vegetation, white crust, and results of the surface scrape test showing the soil beneath, in the northern section of the Site
