# Town of Claresholm

# Infrastructure Master Plan

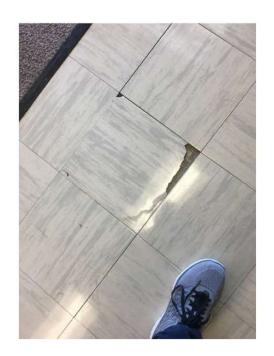
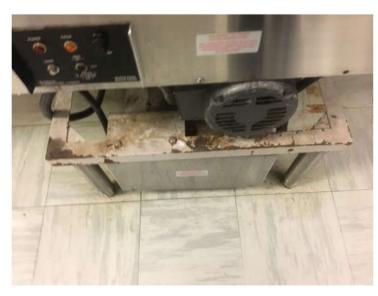
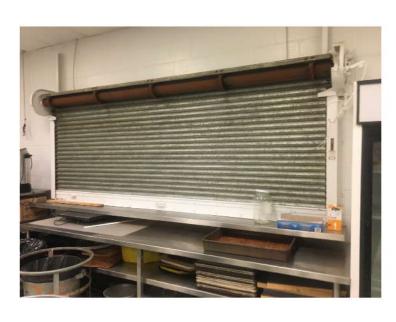
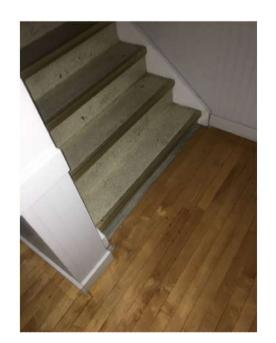
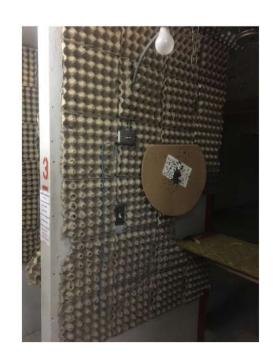
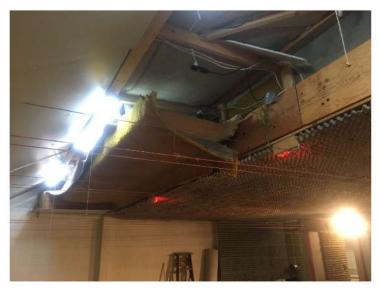
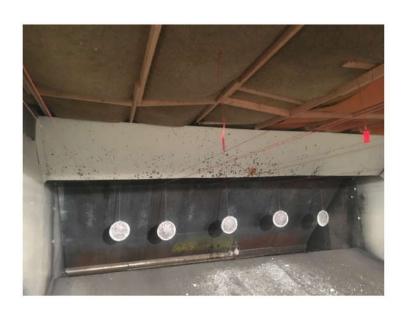
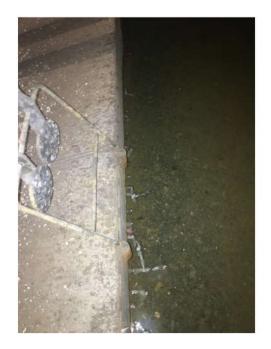
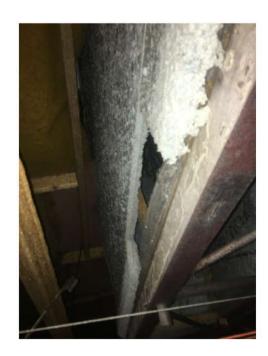
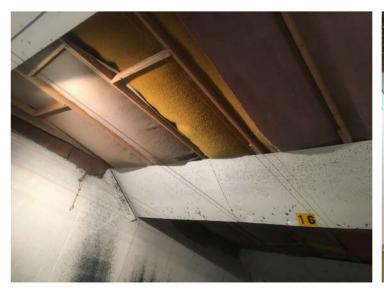
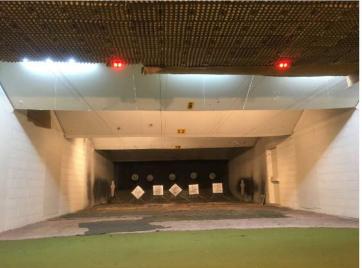
GUN RANGE IS MAJOR FIRE HAZARD, GENERALLY UNSAFE CONDITIONS, EXCEPTIONALLY POOR CONSTRUCTION

MAIN HALL - EXTENSIVE COSMETIC DAMAGE TO CEILING TILES, FLOOR TILES, LIGHT FIXTURE COVERS

EXTERIOR METAL DAMAGE

Roof Structure				Х	ROOF STRUCTURE NOT ACCESSED DURING SITE VISIT	
MECHANICAL	POOR	FAIR	GOOD	N/A	DESCRIPTION / CONCERNS	CRITICAL
Mechanical Room			х		CORRODED FLOOR SLAB / MOLD BEHIND FURNACE	
GENERAL CONDITIONS	POOR	FAIR	GOOD	N/A	DESCRIPTION / CONCERNS	CRITICAL
Entry		х			COSMETIC DRYWALL DAMAGE / DAMAGED CEILING TILES & LIGHT COVERS / DAMAGED VINYL FLOOR TILE	
Main Hall Kitchen		х			CORRODED STEEL FRAME UNDER COMMERCIAL DISHWASHER / NON-FUNCTIONAL ROLL SHUTTER TO MAIN HALL	
Small Hall Kitchen		Х			DAMAGED & UNSANITARY VINYL FLOOR TILE AT SINK	
Main Hall		Х			UNEQUAL RISER HEIGHTS ON STAGE RIGHT STAIRS / MAKESHIFT FLOOR DROP AT WES T EXTERIOR DOORS	
Gun Range	х				DISINTEGRATING RIGID INSLULATION AT CHIMNEY / UNCIRCULATED INDOOR WATER POOL — POTENTIAL MOLD HAZARD / MAKESHIFT WOOD CEILING FRAMING & MATERIALS REPRESENT MAJOR FIRE & SAFETY HAZARD / INACCESSIBLE FOLD-DOWN STAIR TO MEZZANINE REPRESENTS ACCESS & EXITING BUILDING CODE NON-COMPLIANCE / MAKESHIFT OVERHEAD MOTOR & PULLEY SYSTEM IS SAFETY CONCERN / MAKESHIFT LIGHTING & METAL SHIELDING / SINK & VANITY IN POOR CONDITION / UNSECURE VENT COVERS / SIDE EXIT DOOR IS BINDING	Х

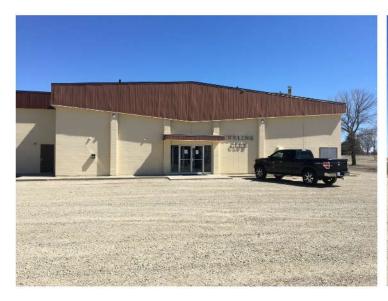
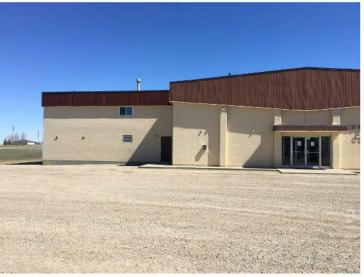
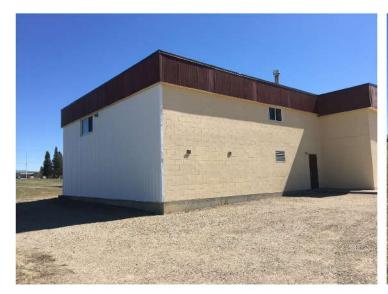
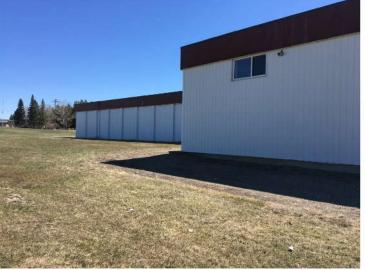
WATER PENETRATION AT INTERIOR OF ROOF TRUSS/WALL CONNECTIONS / POOR EXTERIOR SOFFIT CONDITION

EXTERIOR									
GENERAL CONDITIONS	POOR	FAIR	GOOD	N/A	DESCRIPTION / CONCERNS	CRITICAL			
Parking			х		UNMARKED GRAVEL LOT IN GOOD CONDITION				
Primary Entry		Х			EXTERIOR SLAB SEPARATION FROM ENTRY DOORS				
Walkways		Х			WEST WALKWAY SLAB – NEGATIVE SLOPE TO BUILDING	Х			
Site Grading		Х			GRADING TO BUILDING HIGHER THAN DESIRABLE TO TOP OF SLAB & UNDERSIDE OF BLOCK WALL	Х			
Doorways		Х			EXTERIOR DOOR SEALS / SWEEPS DAYLIGHT OPENINGS / OVERHEAD DOOR SEAL TAPED & FAILING, WOOD THRESHOLD				
Wiindows				Х					
Exterior Finishes		Х			PAINT SEPARATING AT MORTAR JOINTS / NORTH WALL METAL CLADDING (IS THIS OVER BLOCK WALL? FURTHER INVESTIGATION WOULD BE REQUIRED TO DETERMINE BUILDING ENVELOPE INTEGRITY)				
Building Envelope	Х				WATER DAMAGE ON INTERIOR WOOD CEILING OVER RINK AT EXTERIOR WALL, ESPECIALLY AT ROOF TRUSS TO WALL CONNECTION / DAMAGE BLOCK AT MECH. ROOM	Х			
Roof	Х				SOFFIT IN POOR CONDITION / SEPARATED ROOF FLASHING AT SOFFIT	Х

Lighting / Electrical					EXTERIOR LIGHT FIXTURES NOT WEATHERPROOF				
Mechanical		Х			DAMAGED VENT COVERS				
Miscellaneous		Х			DAMAGED METAL CORNER FLASHING /				
SPATIAL SEPARATION	POOR	FAIR	GOOD	N/A	DESCRIPTION / CONCERNS	CRITICAL			
Unprotected Openings			Х		NO NEARBY BUILDINGS TO RESTRICT BUILDING ENVELOPE

Number of Exits		Х			MAIN FLOOR ACCEPTABLE THOUGH SECOND EXIT IS THRU NARROW CORRIDOR / UPPER FLOOR SINGLE EXIT PERMISSIBLE WITH MAX. POSTED OCCUPANCY BUT STAIR HEADROOM NON-CONFORMING	
Electrical		Х			LOOSE HANGING LIGHT FIXTURES NOT MOUNTED TO JUNCTION BOX / EXPOSED WIRES AT MECH. ROOM CEILING	
Storage		Х			DOOR CLOSERS ON STORAGE ROOM DOORS UNATTACHED.	
STRUCTURES	POOR	FAIR	GOOD	N/A	DESCRIPTION / CONCERNS	CRITICAL
Roof Structure		х			WATER DAMAGE TO UPPER CHORD OF ROOF TRUSSES OVER RINK AREA	Х
MECHANICAL	POOR	FAIR	GOOD	N/A	DESCRIPTION / CONCERNS	CRITICAL
Mechanical Room		х			UNSAFE FLOOR DROP & STEP AT ENTRY DOOR / CONDENSATION DAMAGE ON CEILING	
Change Rooms		Х			MENS RM – DRAIN CONNECTION STUBS PROTRUDING FROM FLOOR / LADIES ROOM – WATER DAMAGE TO MILLWORK AT LEFT SINK / MAKESHIFT WATER LINE THRU ROUGH CUT CEILING OPENING	
Bleachers		Х			UNSECURED VENT COVERS OVER BLEACHERS	
Upper Floor		Х			VENT COVERS MISSING / VENTS GENERALLY REQUIRE CLEANING

GENERAL CONDITIONS	POOR	FAIR	GOOD	N/A	DESCRIPTION / CONCERNS	CRITICAL
Entry	х				MISSING FLUORESCENT LIGHT COVER	
Main Floor Kitchen		Х			GENERALLY DATED & SANITATION CONERNS AT MILLWORK & BACKSPLASH / MAKESHIFT OVERHEAD ELECTRICAL CONNECTION	
Upper Floor Kitchen		Х			WALLS SEPARATED FROM CEILING / DAMAGED CEILING TILES	
Washroom Distribution					WATERCLOSET FACILITIES MALE/FEMALE DISTRIBUTION IS SKEWED OPPOSITE TO CODE REQUIREMENTS

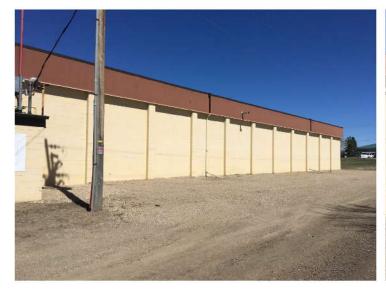
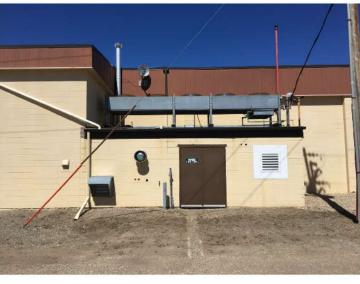
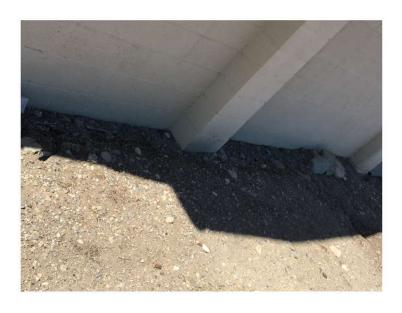
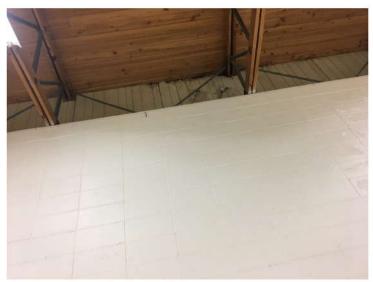
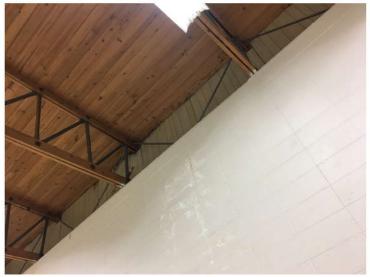
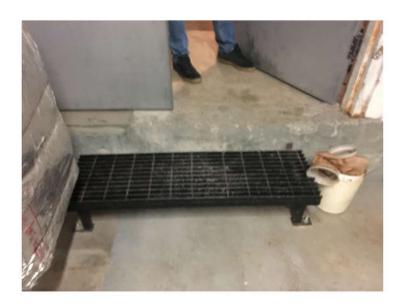
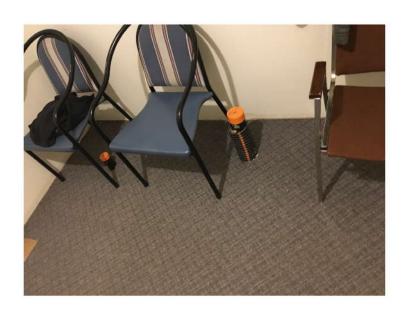
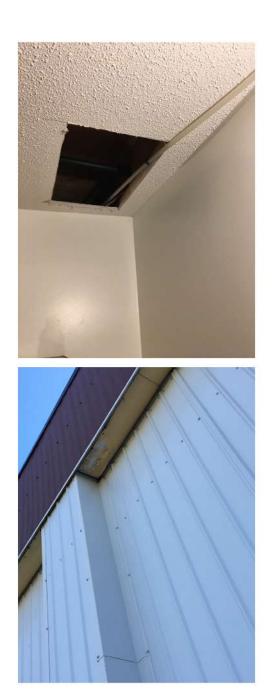
ADDRESS			OCCUPIED
	4505 – 5TH STREET E	EAST	IN USE
<b>OVERALL STATE:</b>	AGE	<b>BUILDING DESCRIPTION</b>	
FAIR	UNKNOWN	EAST SIDE RESERVO	DIR
<b>OVERALL ISSUES:</b>			
TREATED WATER LEAKING TO SU	MP & PUMPED TO DRAF	INAGE	
TANK WALL TO ROOF SEALANT FA	AILING

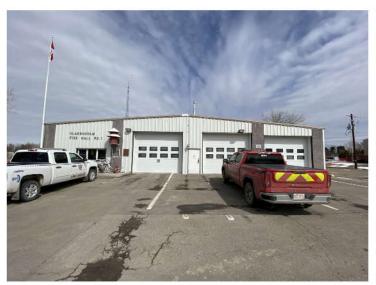
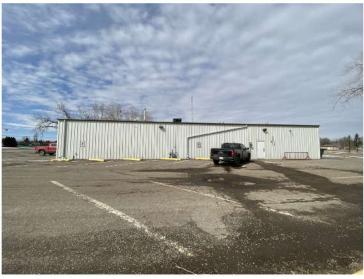
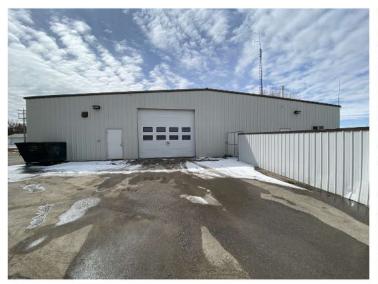
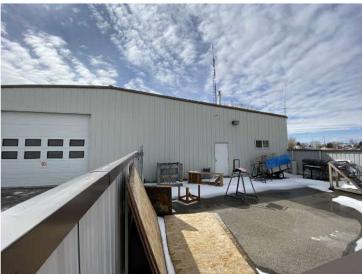
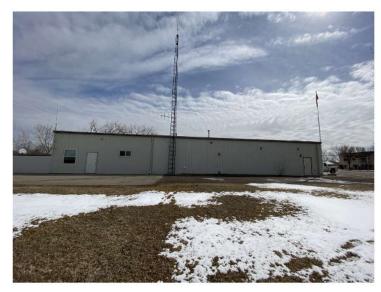
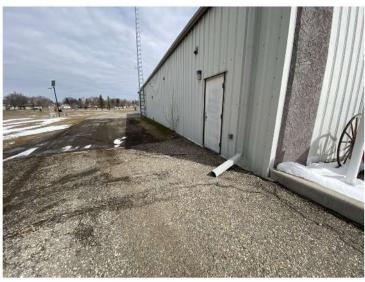
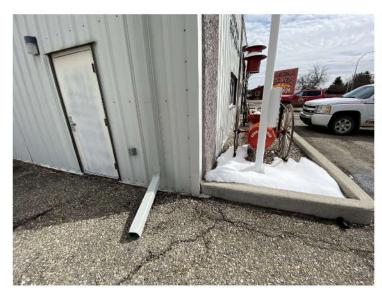
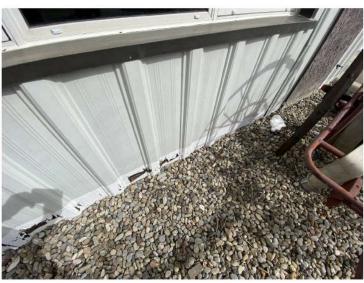
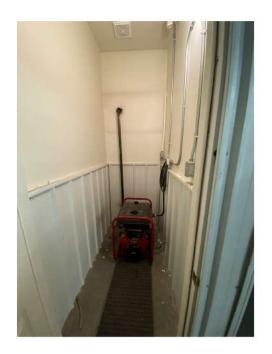
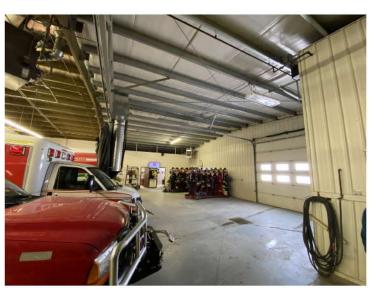
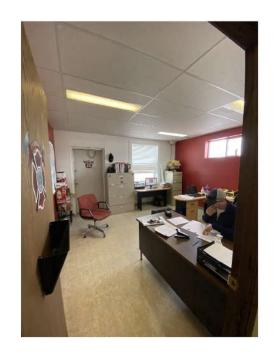
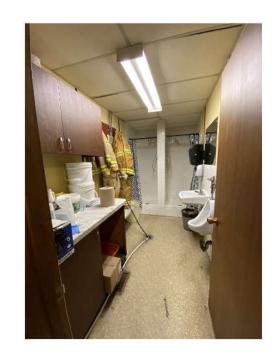
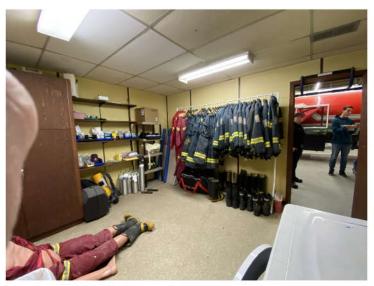
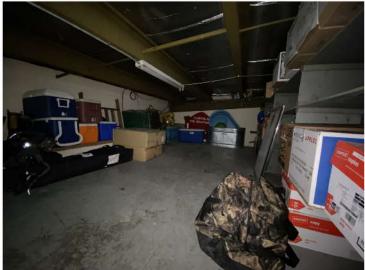
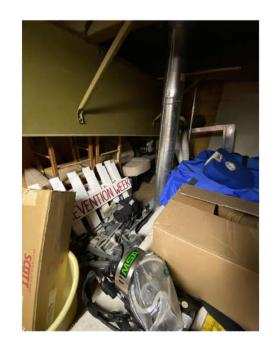
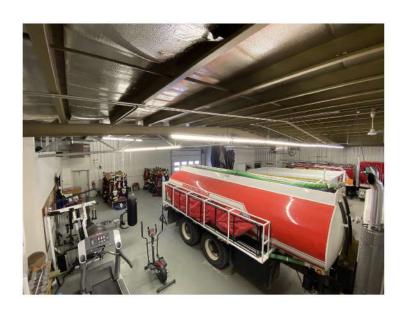
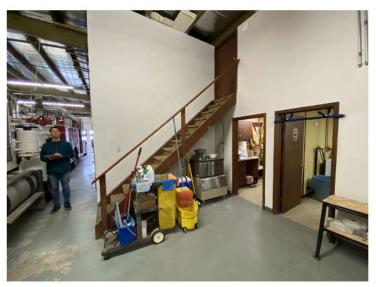
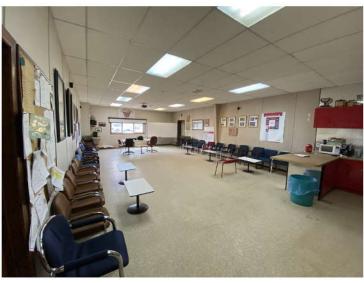
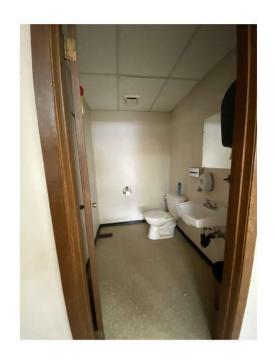
ADDRESS			OCCUPIED
(3)	YES		
<b>OVERALL STATE:</b>	AGE	<b>BUILDING DESCRIPTION</b>	
GOOD	1979	FIRE HALL

EXHUAST FAN LEAKS

EXTERIOR								
GENERAL CONDITIONS	POOR	FAIR	GOOD	N/A	DESCRIPTION / CONCERNS	CRITICAL		
Parking			х		PAVING IMPERFECTIONS			
Primary Entry			Х					
Walkways			Х					
Site Grading	Х				EXISTING PAVING & WALKWAYS BUILT UP HIGHER THAN FLOOR SLAB / ICE BUILT-UP ALL AROUND BUILDING	Х		
Doorways			Х					
Windows			Х					
Exterior Finishes		Х			FRONT DISPLAY CAUSING RUST ON EXTERIOR SHEET METAL FINISH			
Building Envelope			Х		METAL FINISHES ON STEEL STRUCTURE – GENERALLY GOOD CONDITION			
Roof			Х					
Lighting / Electrical			Х					
Mechanical		Х			LEAKS AROUND EXHAUST FANS / EMERGENCY GENERATOR ON SITE			
SPATIAL SEPARATION	POOR	FAIR	GOOD	N/A	DESCRIPTION / CONCERNS	CRITICAL		
Unprotected Openings			х		NO NEARBY BUILDINGS TO RESTRICT BUILDING ENVELOPE

INTERIOR	
ACCESSIBILITY	POOR	FAIR	GOOD	N/A	DESCRIPTION / CONCERNS	CRITICA
H/C Operators	х				NO H/C OPERATOR AT PRIMARY ENTRANCE	
Washrooms		Х			REQUIRED NUMBER OF WATER CLOSETS NOT PROVIDED / MILLWORK IS DATED / LOOSE CEILING TILES / LEAKS AROUND EXHAUST FANS	
Doorways			х			
Path of Travel			х			
FIRE SAFETY	POOR	FAIR	GOOD	N/A	DESCRIPTION / CONCERNS	CRITICAL
Rated Doors			х			
Fire Separations			Х			
Structural Fire Protection			Х			
Exit Stairs		Х			MEZZANINE STAIR IS OLD / HANDRAIL DOES NOT MEET MINIMUM SPACING REQUIREMENTS	
Number of Exits			Х			
Electrical			Х		WASHROOM FLUORESCENT LIGHT FIXTURE MISSING COVER / CO2 SENSORS INSTALLED THROUGHOUT	
Storage				Х	LOW HEADROOM THROUGHOUT MEZZANINE STORAGE AREA / STORAGE AROUND EXPOSED METAL FURNACE EXHAUST PIPE	Х
STRUCTURES	POOR	FAIR	GOOD	N/A	DESCRIPTION / CONCERNS	CRITICAL
Roof Structure			х			
MECHANICAL	POOR	FAIR	GOOD	N/A	DESCRIPTION / CONCERNS	CRITICAL

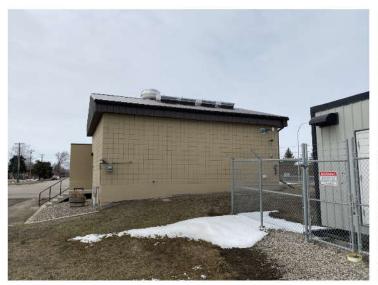
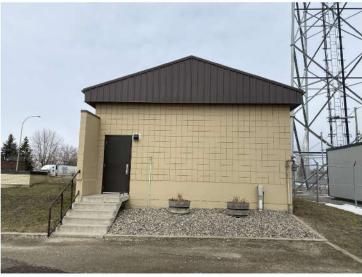
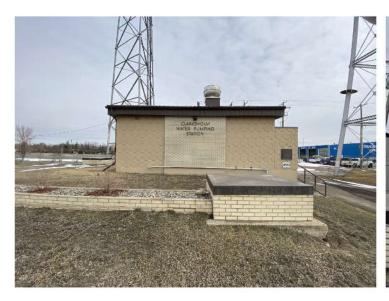
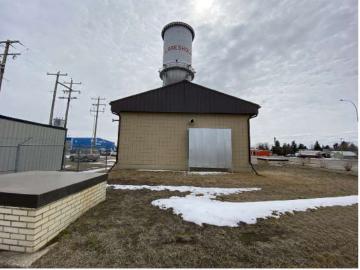
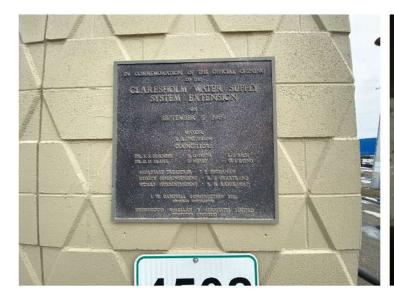
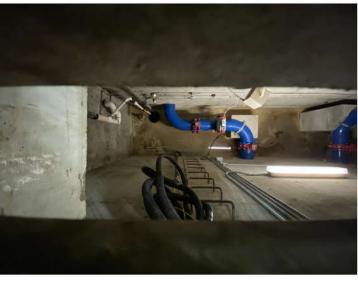
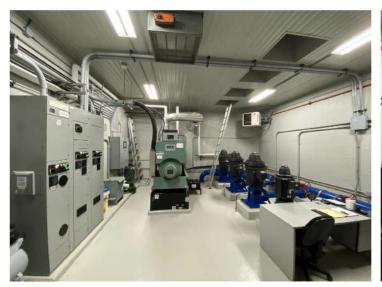
#### Highway Pump Station

ADDRESS			OCCUPIED
	4502 1 <sup>st</sup> STREET WE	EST	IN USE
OVERALL STATE:	AGE	BUILDING DESCRIPTION	
GOOD	1969	HIGHWAY PUMP STA	TION
<b>OVERALL ISSUES:</b>			
GOOD CONDITION – NO SIGNIFIC	ANT ISSUES

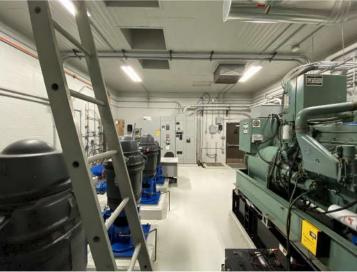
ADDRESS			OCCUPIED
	SW19-12-27-W4		IN USE
OVERALL STATE:	AGE	BUILDING DESCRIPTION	
GOOD	2015	LAGOON LIFT STATI	ON
OVERALL ISSUES:			
WATER PENETRATION THROUGH	NORTH BLOCK WALL

EXTERIOR										
GENERAL CONDITIONS	POOR	FAIR	GOOD	N/A	DESCRIPTION / CONCERNS	CRITICAL				
Parking				Х						
Primary Entry			х							
Walkways			х							
Site Grading			х							
Doorways			х							
Windows				Х						
Exterior Finishes			х							
Building Envelope		Х			WATER PENETRATION THROUGH NORTH BLOCK WALL, HAS BEEN RESEALED PREVIOUSLY					
Roof			х							
Lighting / Electrical			х							
Mechanical			х							
Miscellaneous			7	Х						
SPATIAL SEPARATION	POOR	FAIR	GOOD	N/A	DESCRIPTION / CONCERNS	CRITICAL				
Unprotected Openings			'	Х	NO NEARBY BUILDINGS TO RESTRICT BUILDING ENVELOPE					
					•

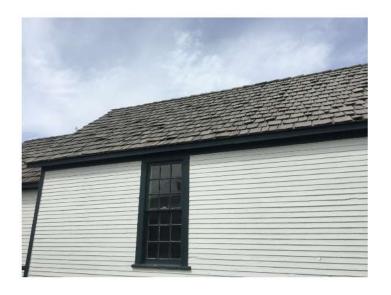
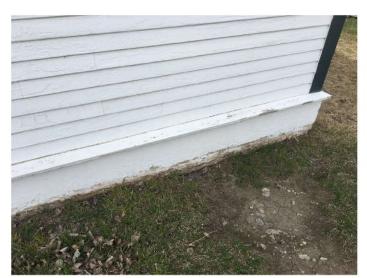
#### Museum School House

# ADDRESS 5126 1st STREET WEST NO OVERALL STATE: AGE BUILDING DESCRIPTION FAIR 1903 MUSEUM SCHOOLHOUSE (HISTORICAL BUILDING)

EXTERIOR PAINT & WOOD SKIRT BOARD IN POOR CONDITION

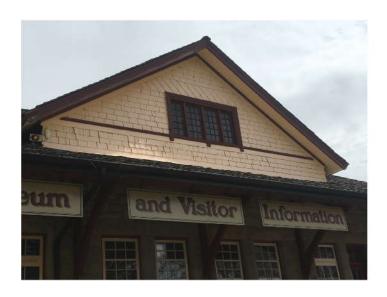
EXTERIOR SANDSTONE CRACKING

WEST ROOF GABLE WOOD SHAKES IN POOR CONDITION (CRITICAL)

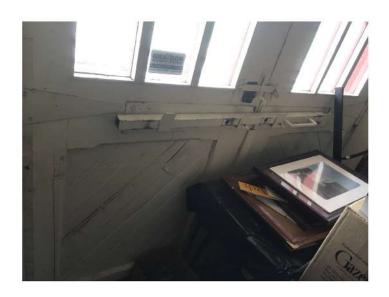
#### Museum Station Building

CRAWLSPACE WOOD COLUMN WATER DAMAGE

DOORS IN GENERALLY POOR CONDITION
